# Babylon Fire Burned Area Summary

## Burned Area Report

### Fire Background

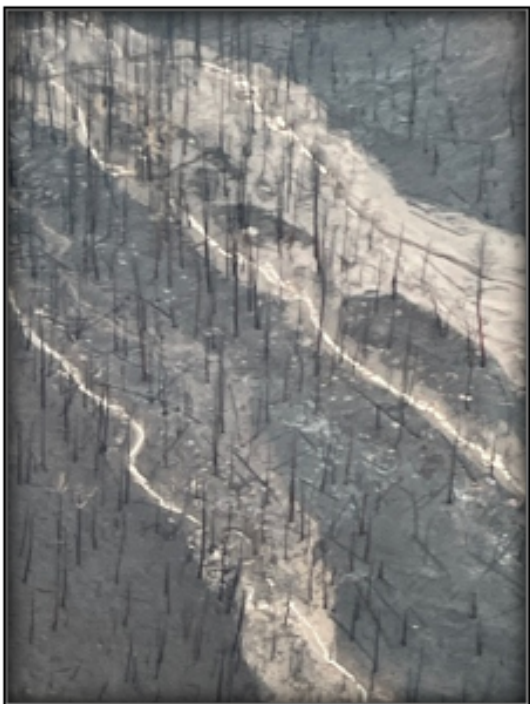
Patchy, summer monsoon rainfall fell within the forest and burned area perimeter during the field assessment and this produced observable watershed responses in the burned area. There was an initial flush of ash, coupled with rill and gully erosion on hillslopes. Increased surface runoff delivered ash and sediment-laden flows into channelized drainages.

The team's rapid hydrologic assessment observed increased flows and high turbidity due to the postfire environment, which may impact water-quality (elevated levels of ash, fine sediment, nutrients and dissolved organic carbon). These processes will attenuate over time and should recover to pre-fire conditions over the next several years.

*Photo 2. Ash, sediment, and debris flushed and transported during and after rain events outside the burned area.*

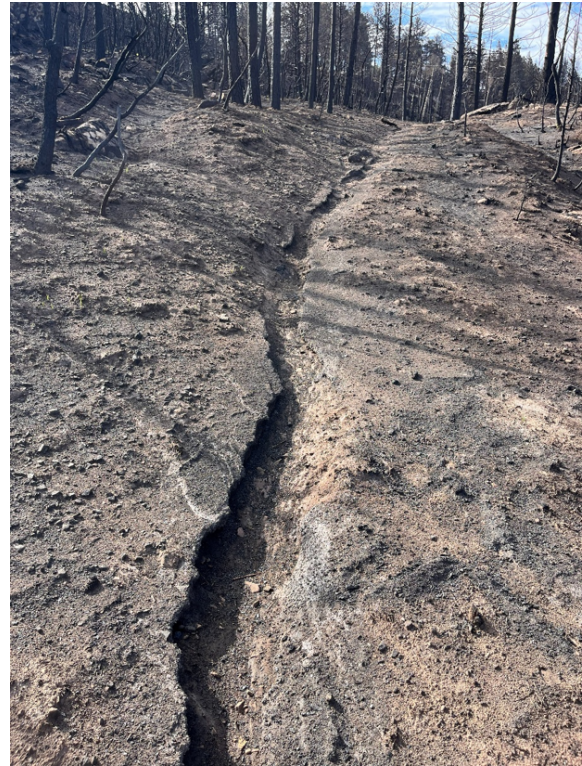
*Photo 4. Evidence of increased erosion on the Horse Pasture trail.*

sure they are functioning properly. Planning based on these scouting reports will reduce further loss and degradation of trail tread and structural features while minimizing erosion and avoiding costly future reconstruction efforts. Physical closure would involve gates at key entry points for motorized recreation. These gates would be installed on the motorized trails to close the trails until vegetation is established and stabilizes the surrounding soils.
